**CAPITAL RESERVE STUDY**  
FOR  
**REGENCY HILLS SUBDIVISION**

PREPARED FOR:

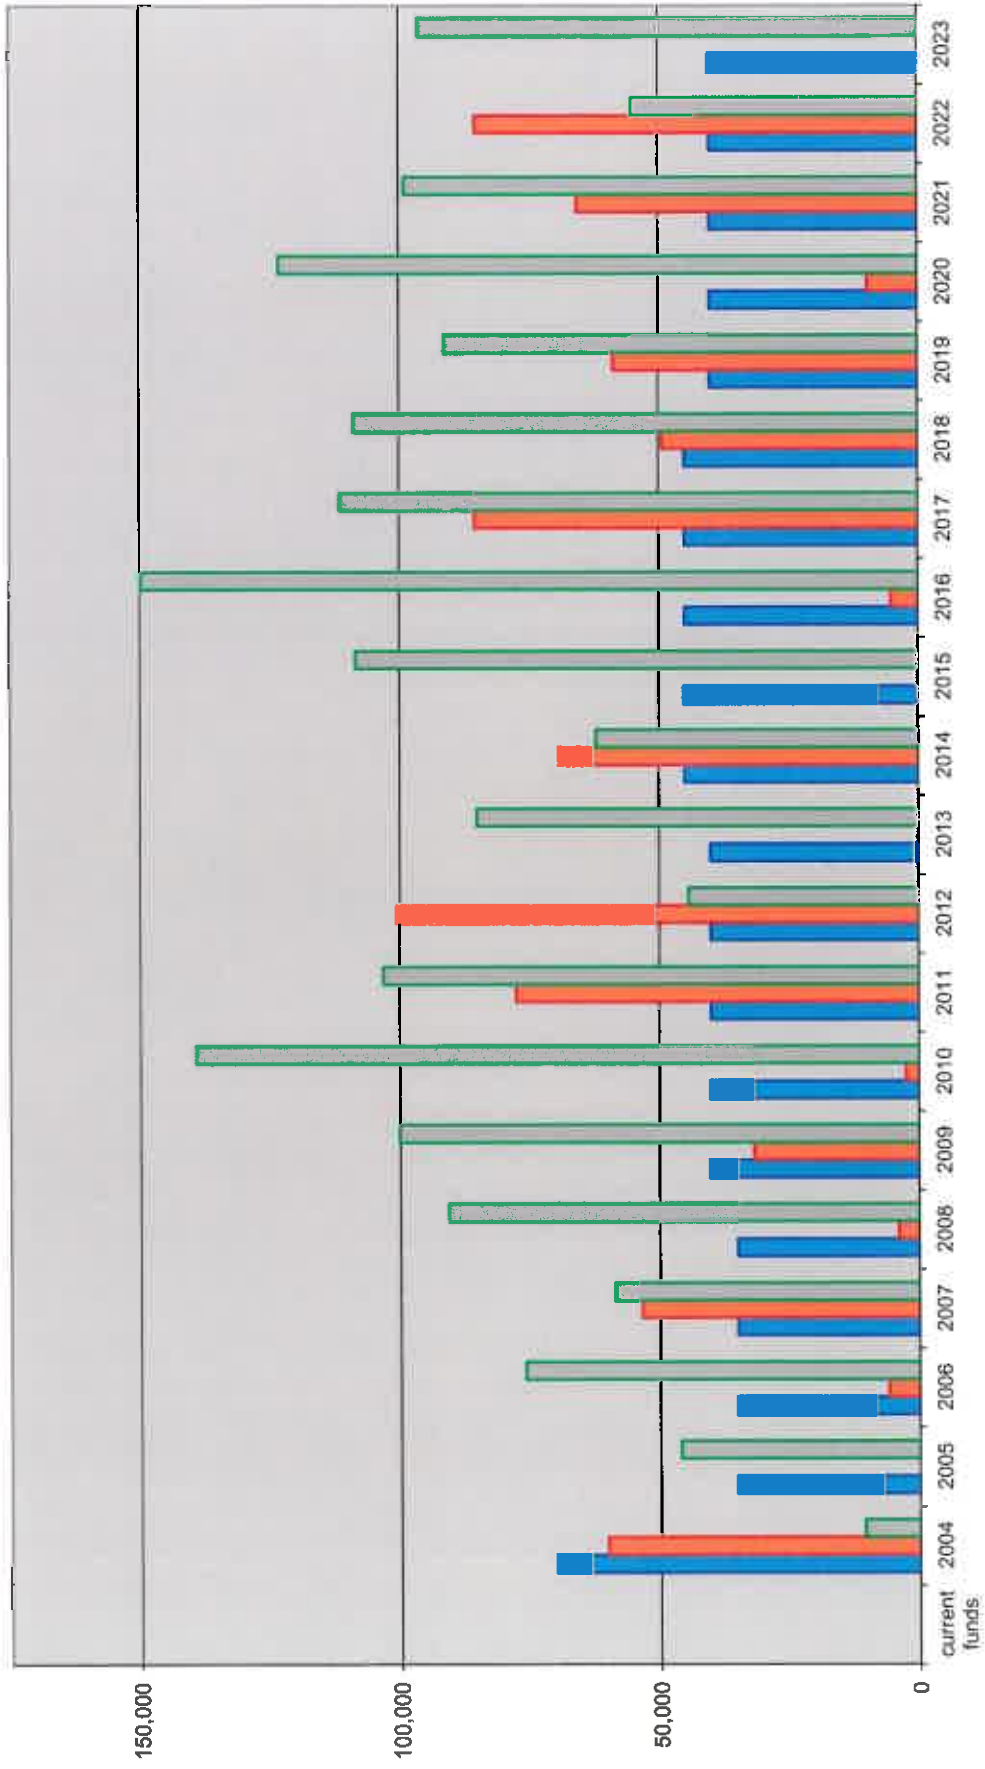
■ Annual Funds ■ Future Expenses ■ Net Accumulated Funds

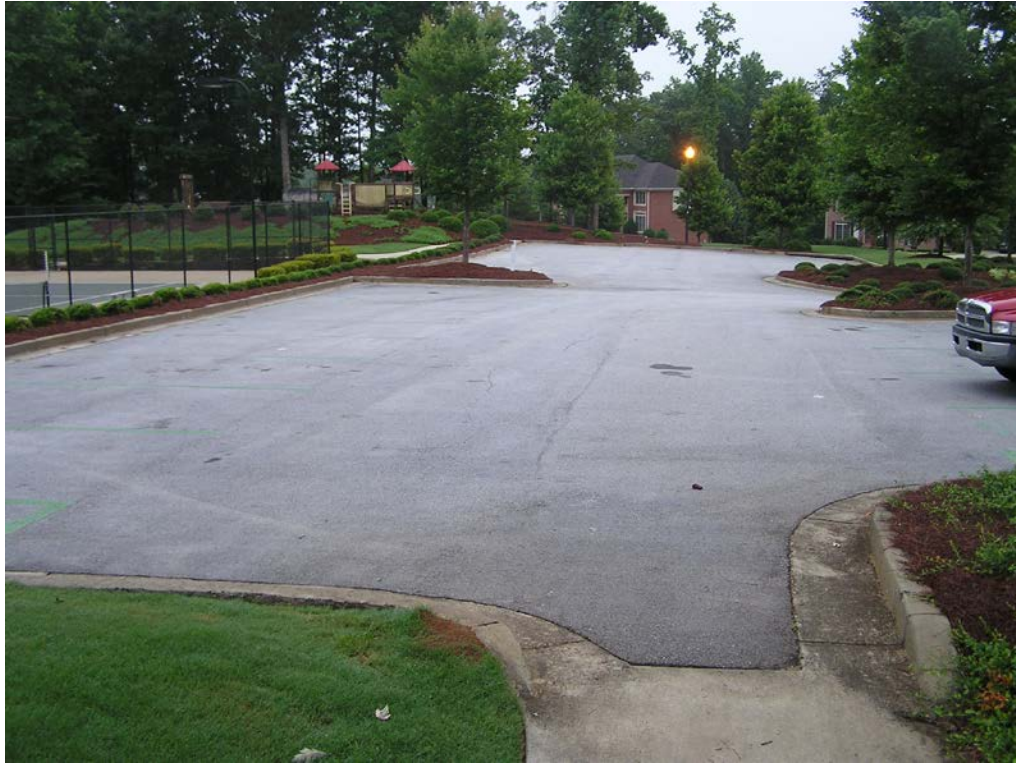
1. General view of the parking lot showing some of the minor cracks in the pavement surface.

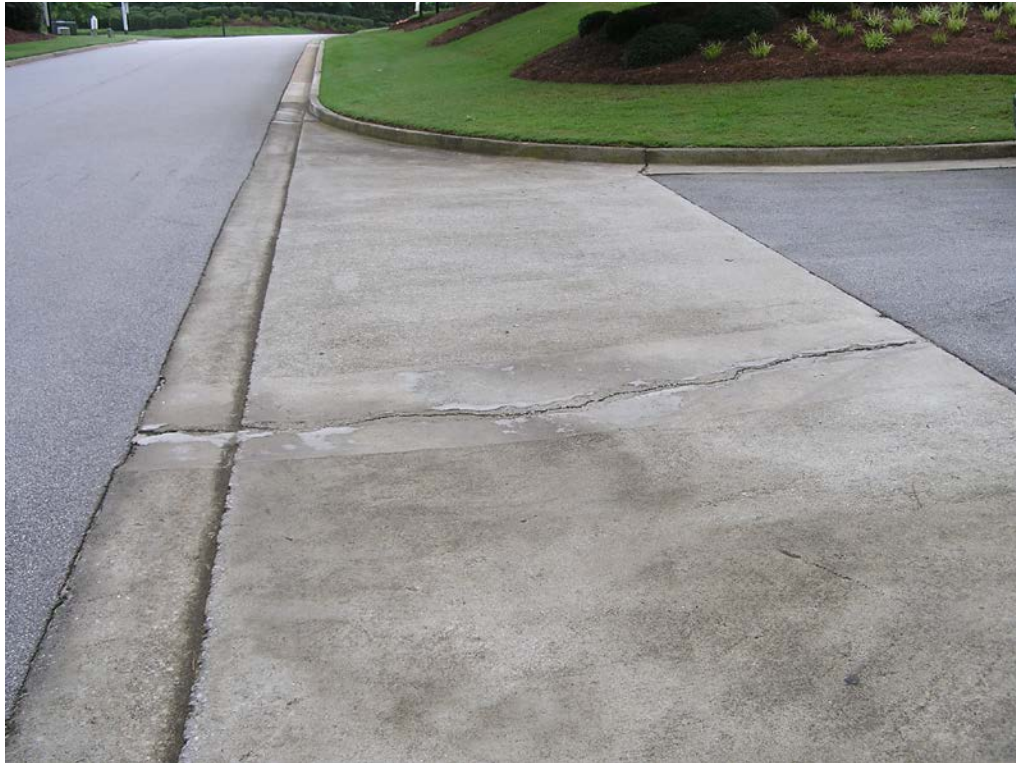
2. View showing a crack in the concrete of the parking lot entry apron.

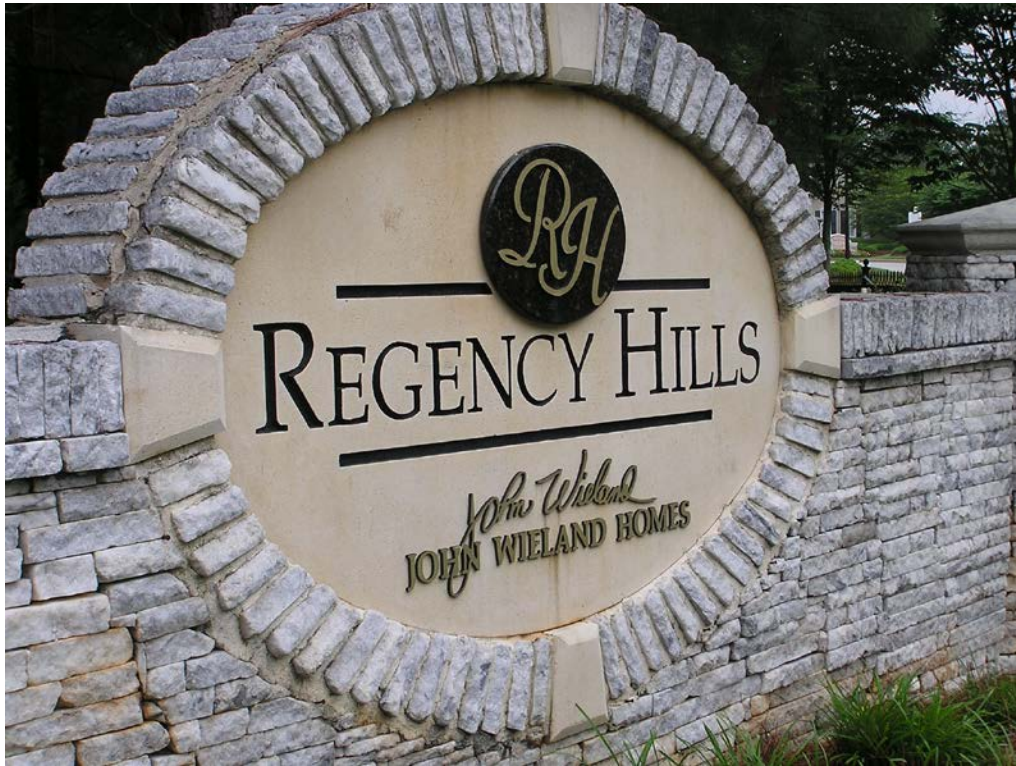
3. View showing the stained and dirty logo sign at the property entry.

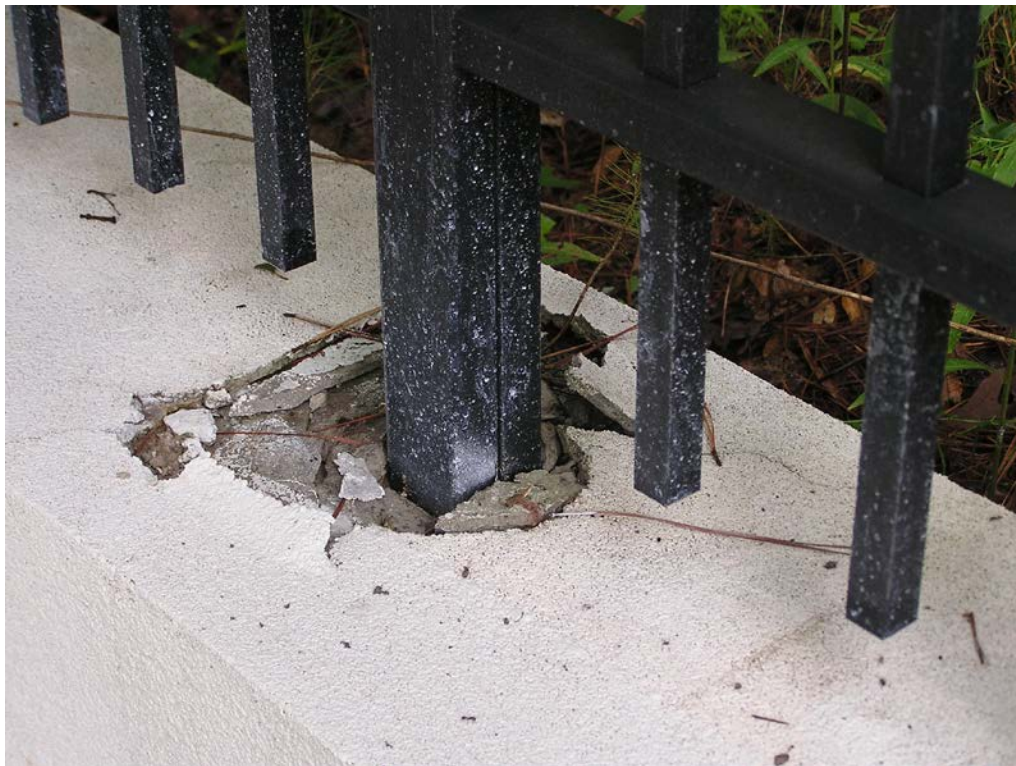
4. View showing a loose fence post and deteriorated stucco finish at the wall paralleling the main entry drive.

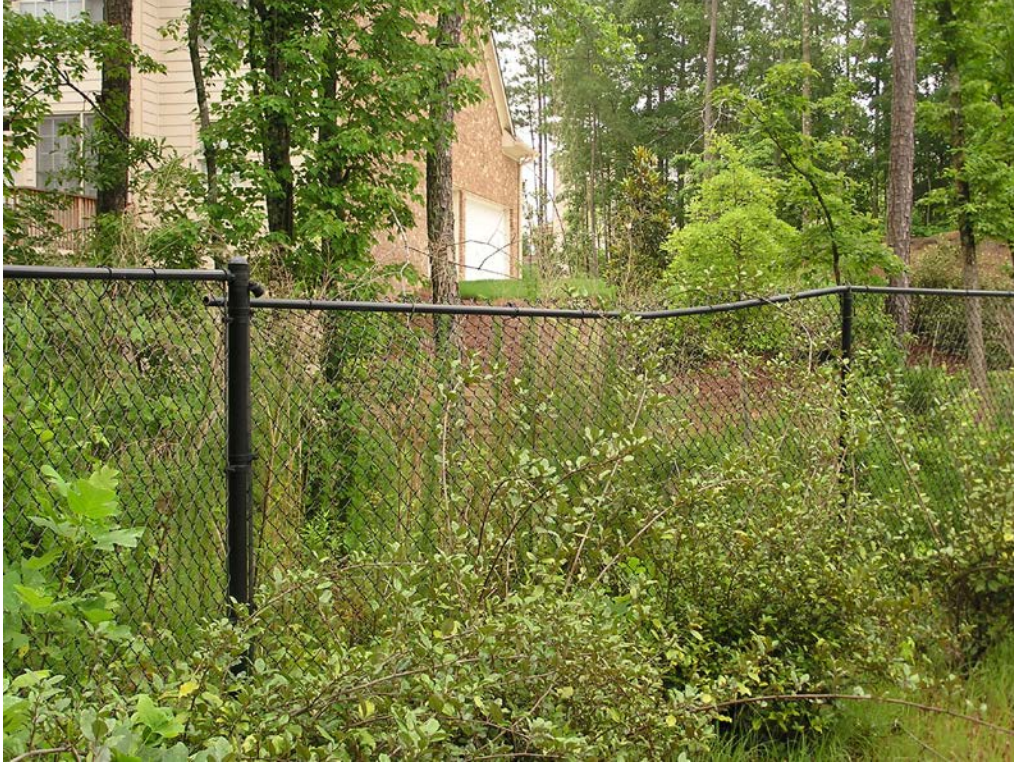
5. Damaged chain link fence at the detention pond adjacent to 5425 Stone Croft Trail.

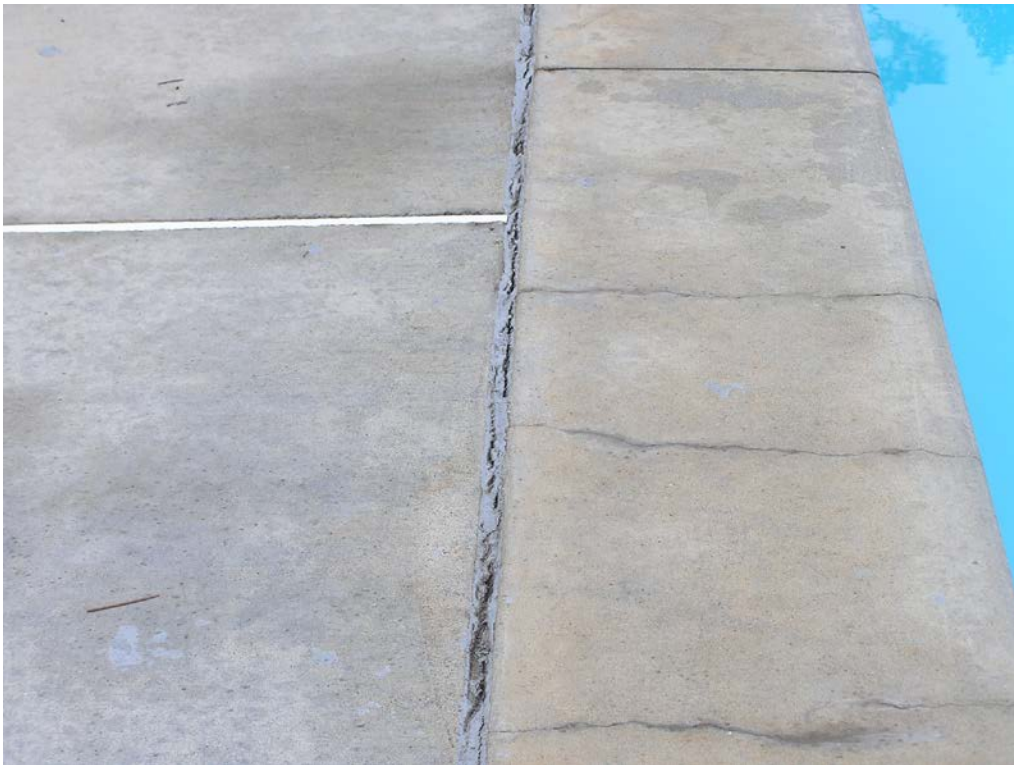
6. Deteriorated caulk joint at the main pool.

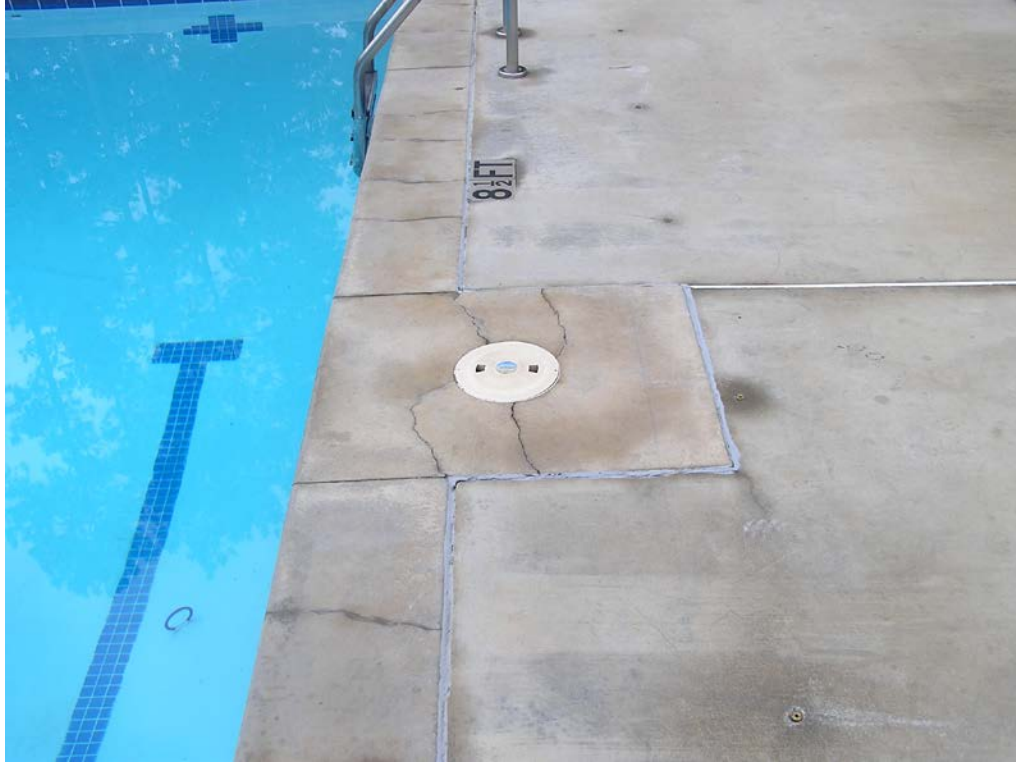
7. Cracks in the concrete deck at a typical skimmer opening at the main pool.

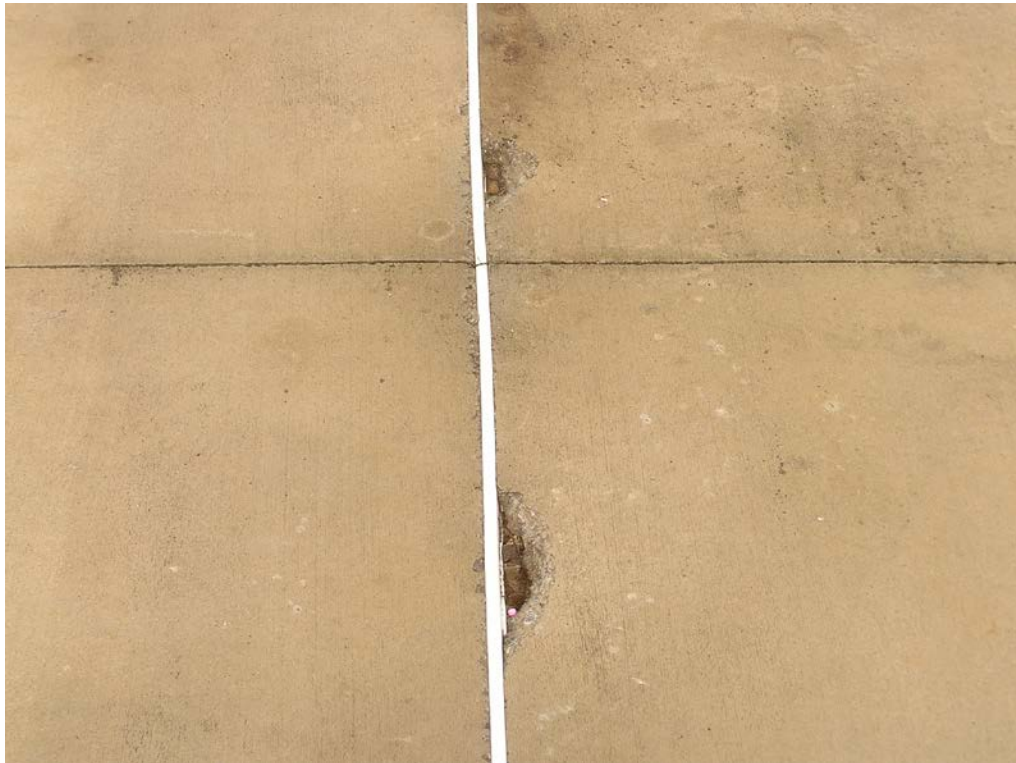
8. View of the main pool deck showing the spalled concrete that has occurred where the wood formwork stakes were not removed.

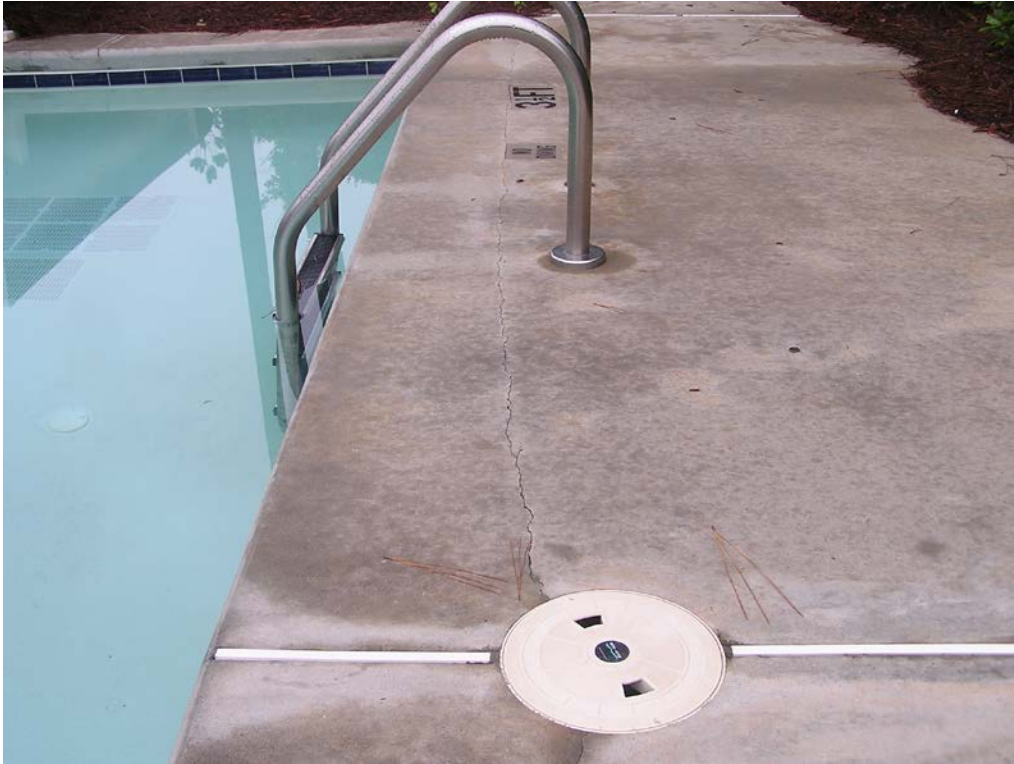
9. Hairline crack at the waterslide pool that appears to have occurred due to slight settlement.

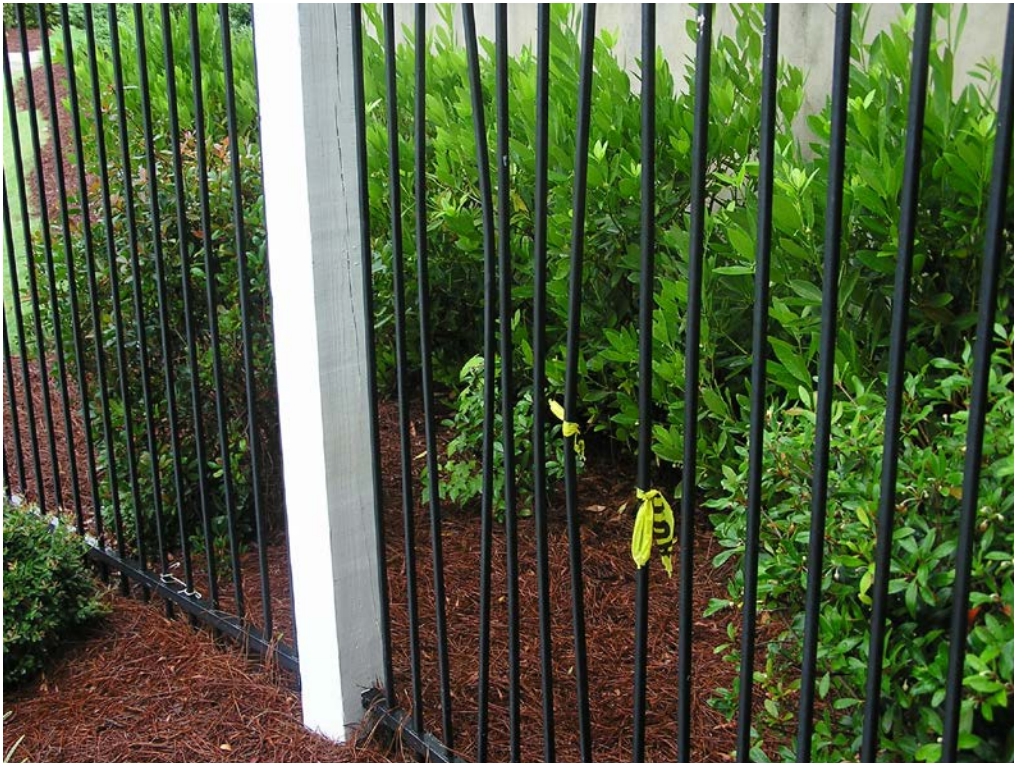
10. Typical damaged aluminum fence pickets at the perimeter fence surrounding the pool deck.

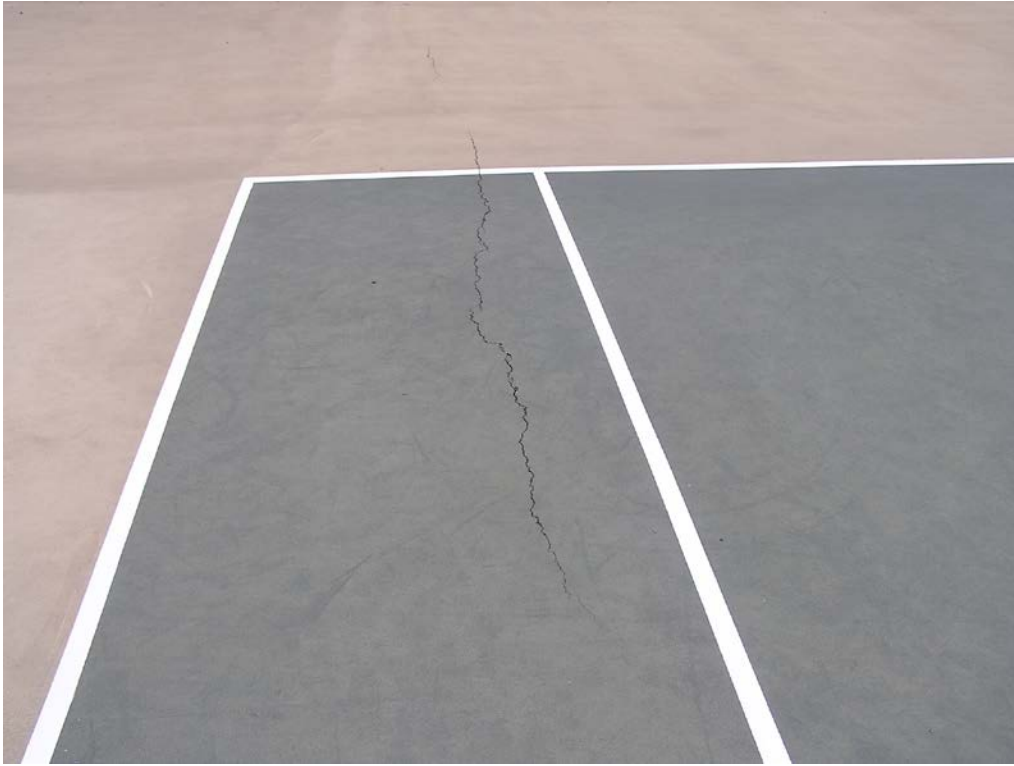
11. View showing typical cracks in the asphalt wearing course of the tennis courts.

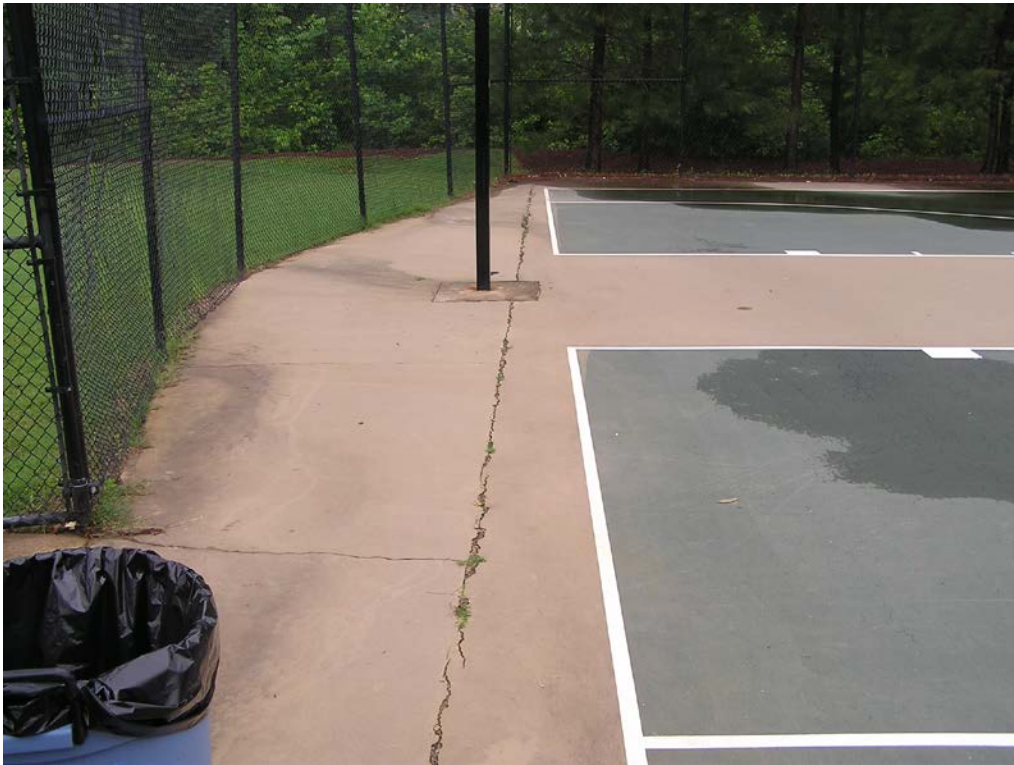
12. Deteriorated cold joints in the asphalt surface of the basketball court.

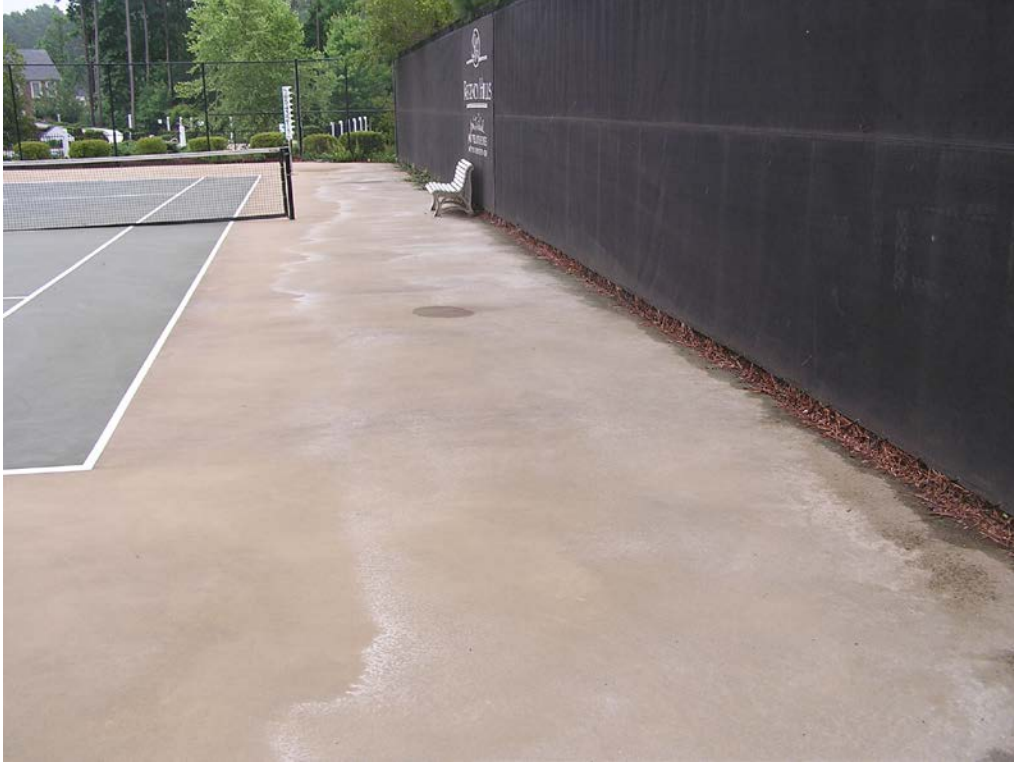
13. View showing evidence of ponding water at the south side of the tennis courts.

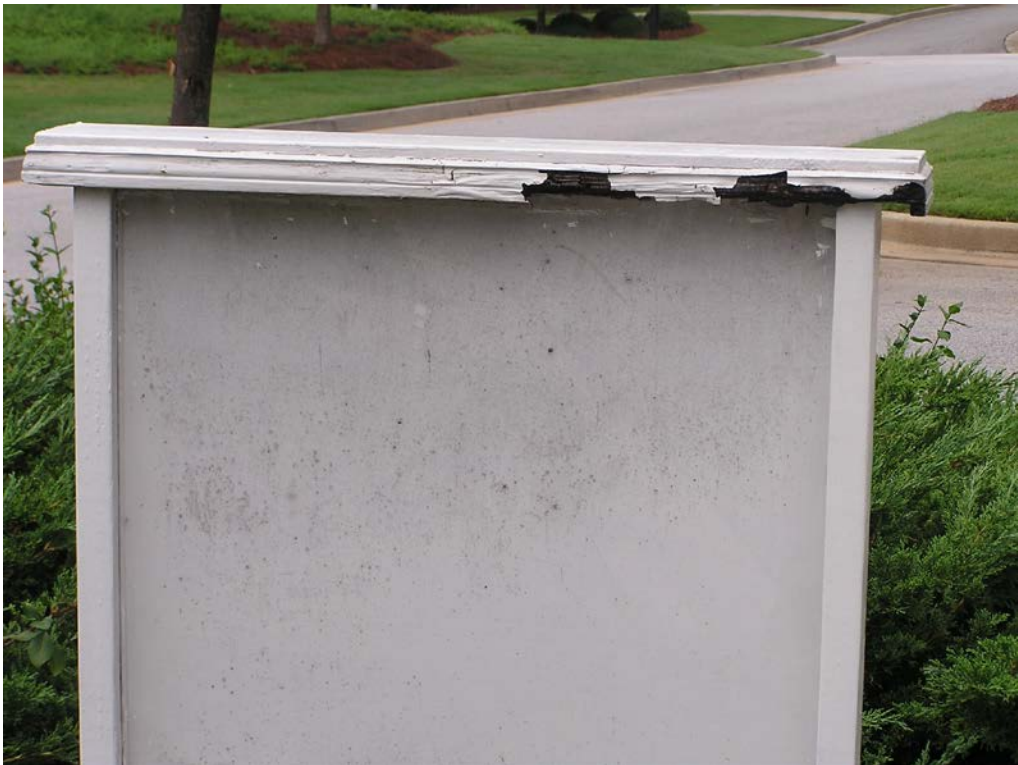
22. Deteriorated wood trim at the information sign located adjacent to the guardhouse.

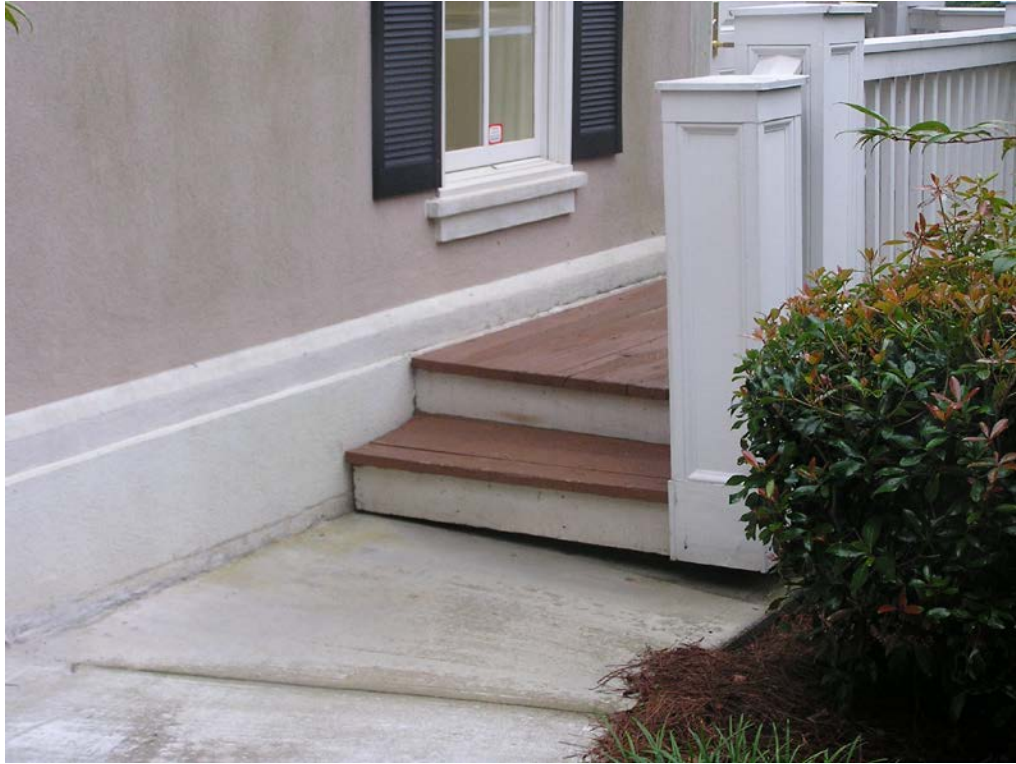
23. Collapsed wood step located at the right side of the clubhouse.

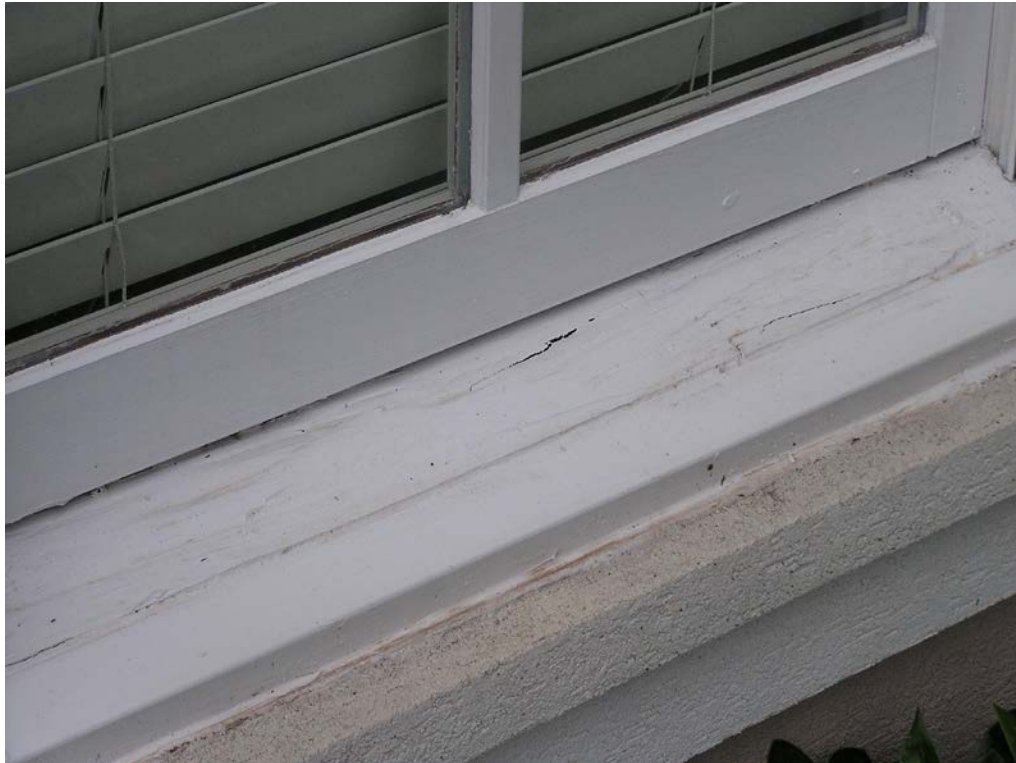
24. Deteriorated wood windowsill at the right front side of the clubhouse.

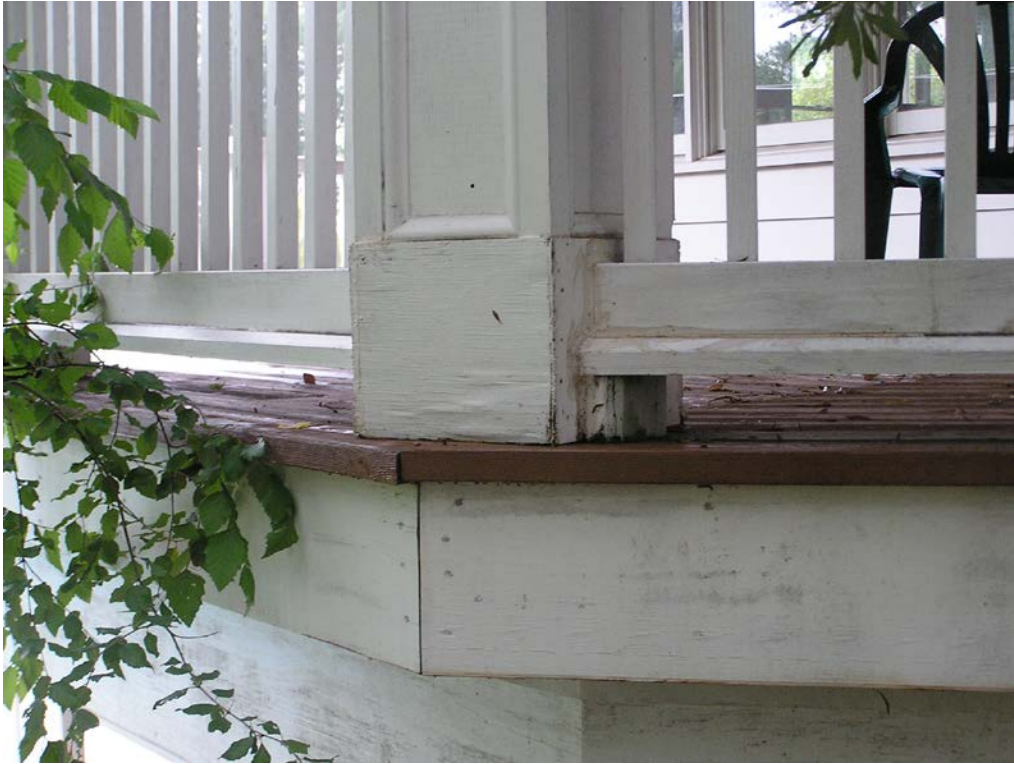
25. View showing the deteriorated wood column casing at the upper level deck at the rear of the clubhouse.

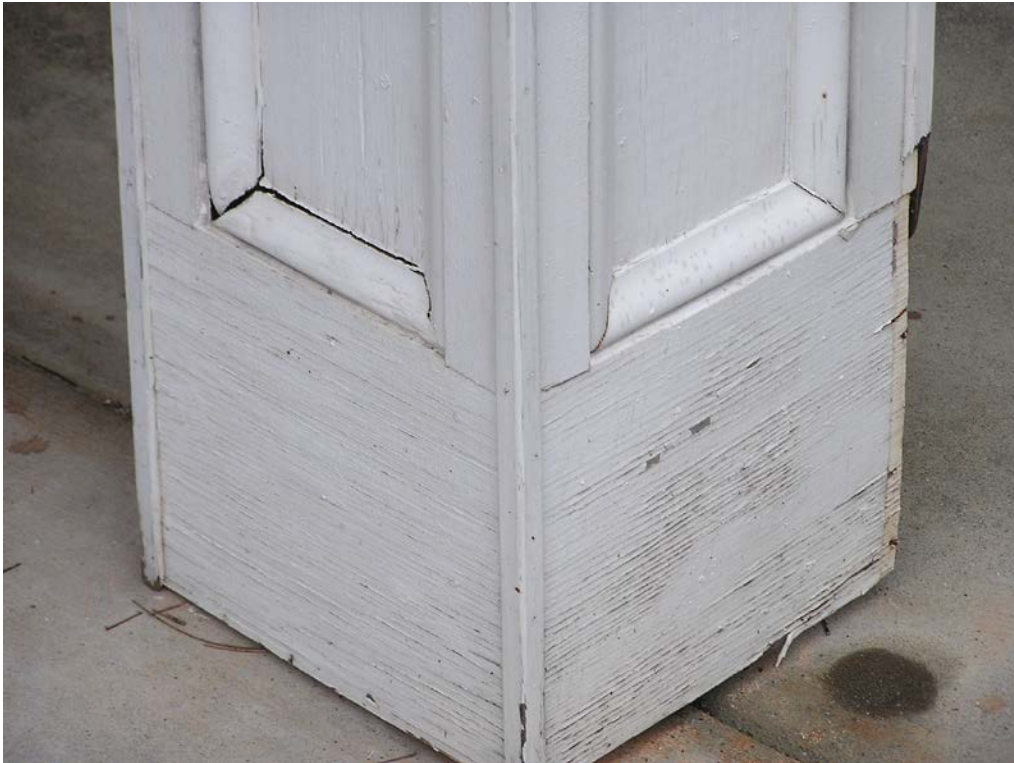
26. Typical deteriorated wood casing and trim at the bottom of a column located at the lower level rear deck of the clubhouse.

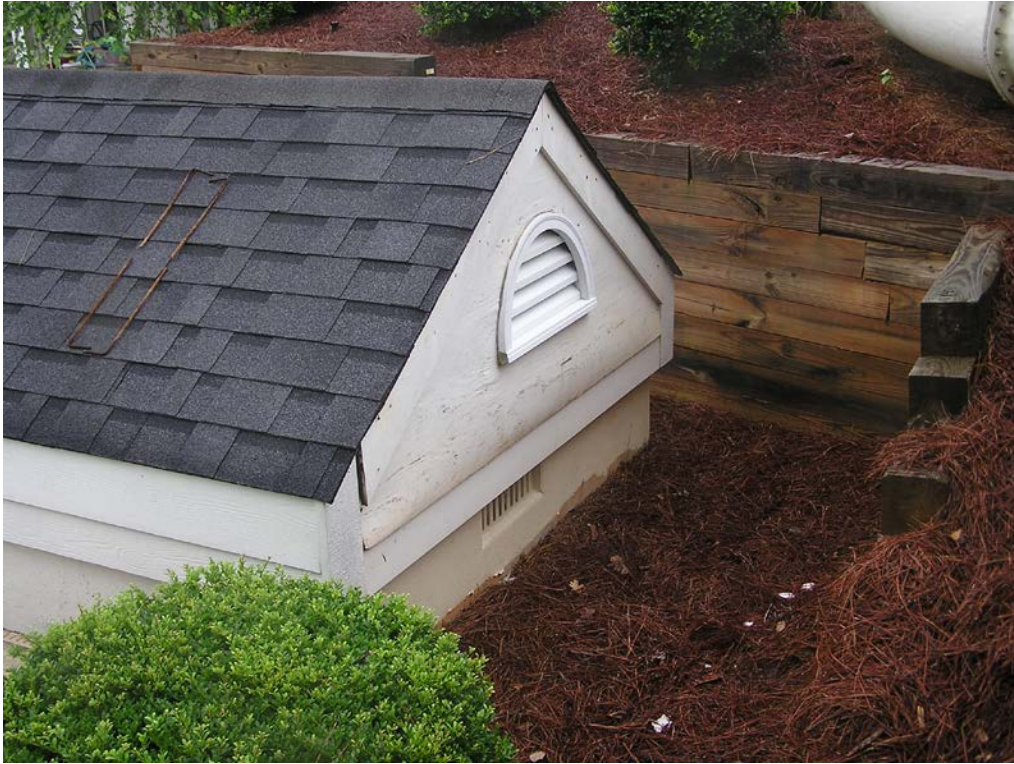
27. Typical deteriorated wood casing at the top of a column located at the lower level rear deck of the clubhouse.

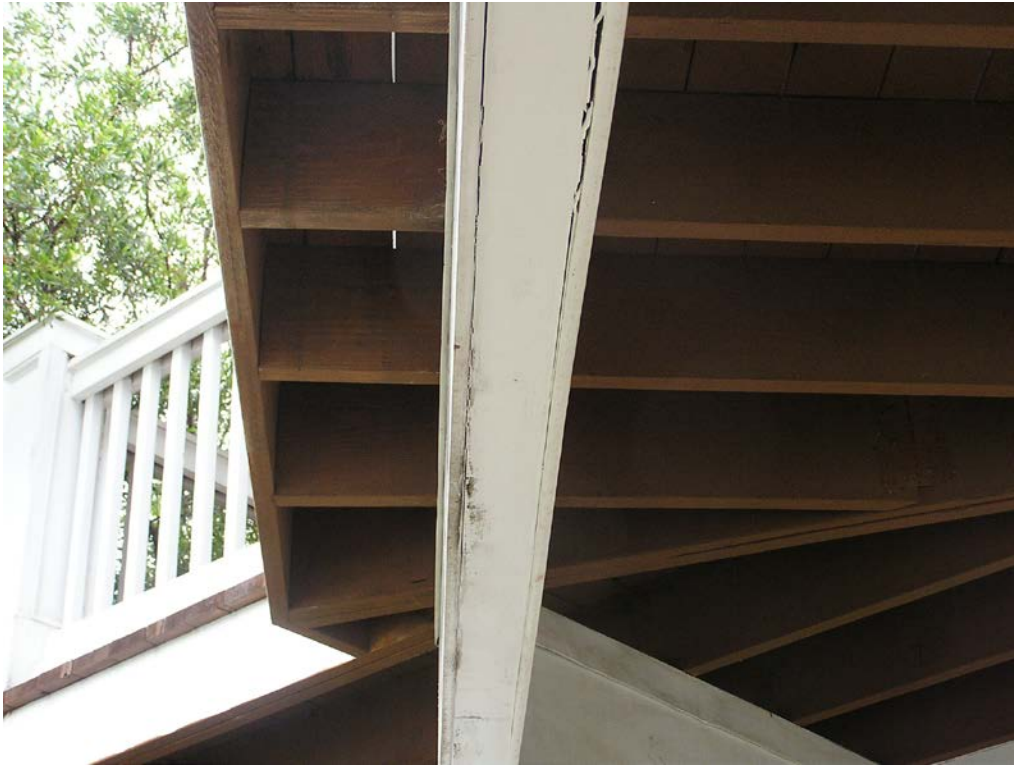
28. View showing deteriorated wood casing and trim at a support beam located at the lower level rear deck of the clubhouse.

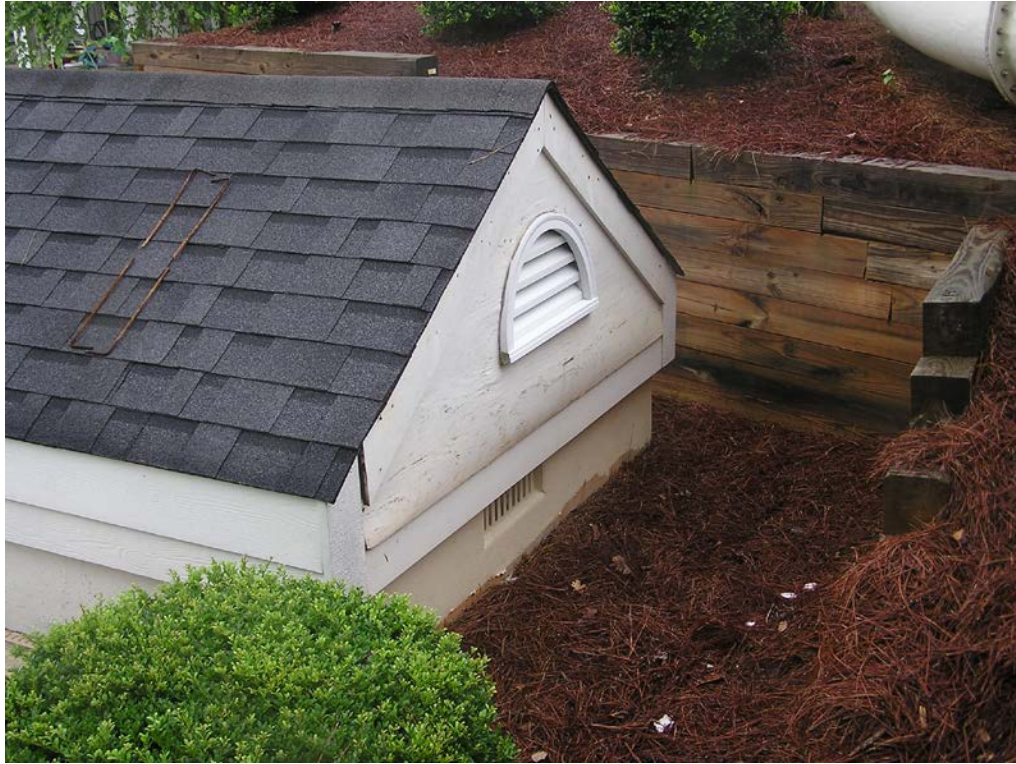
29. Deteriorated wood access panel at the waterslide pump house.

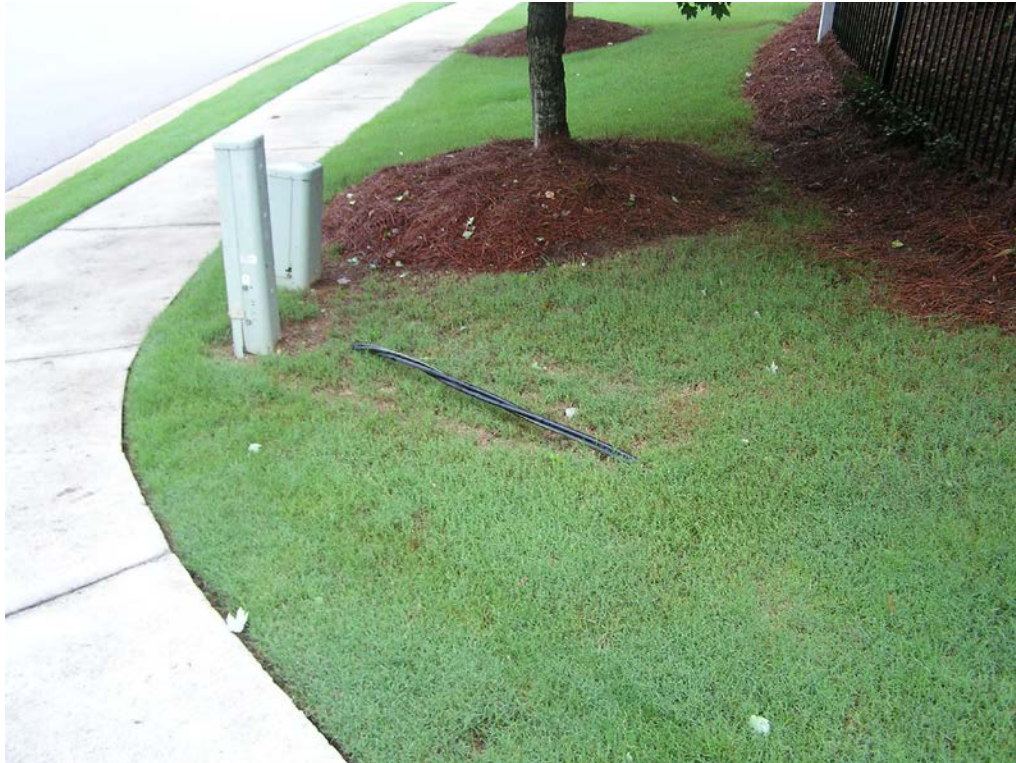
30. Exposed electrical cable at the sidewalk located near the left front side of the clubhouse.

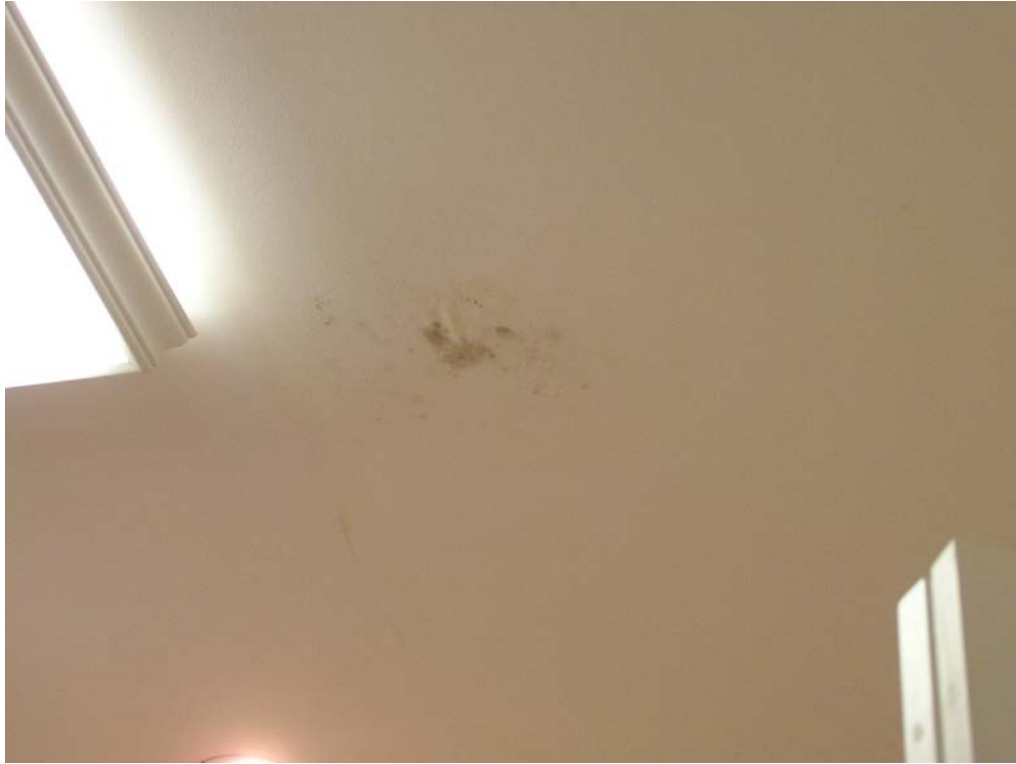
31. View of the kitchen ceiling showing mildew stains, indicating a possible leak problem.

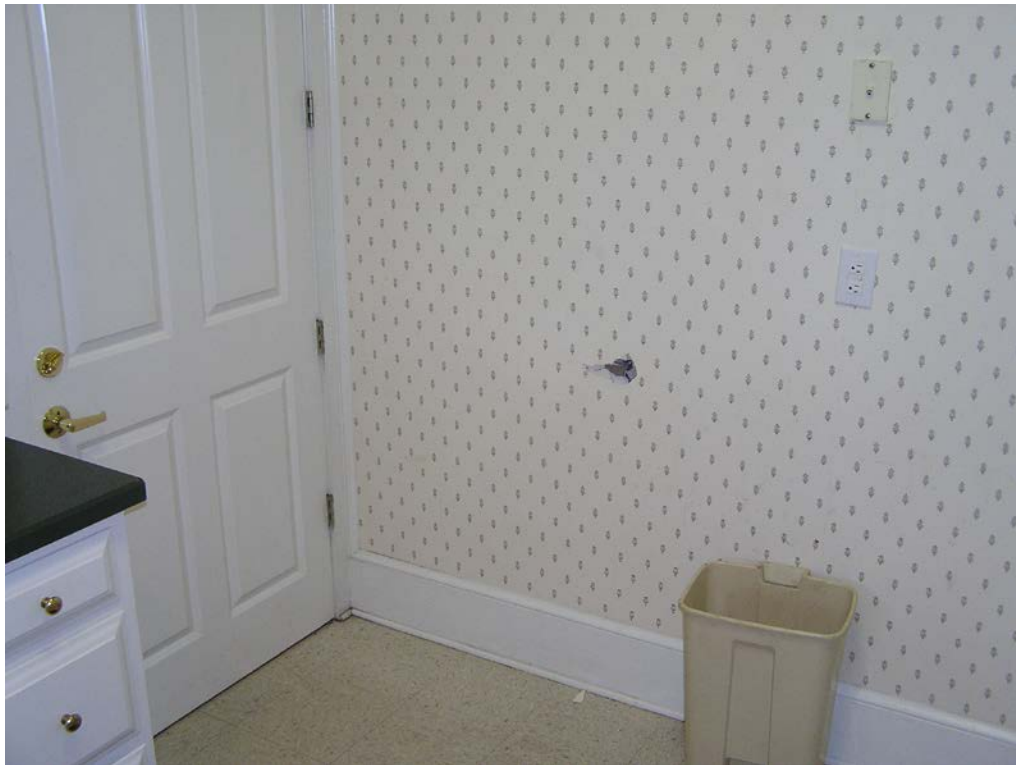
32. View of the kitchen showing the hole in the wall behind the entry door.

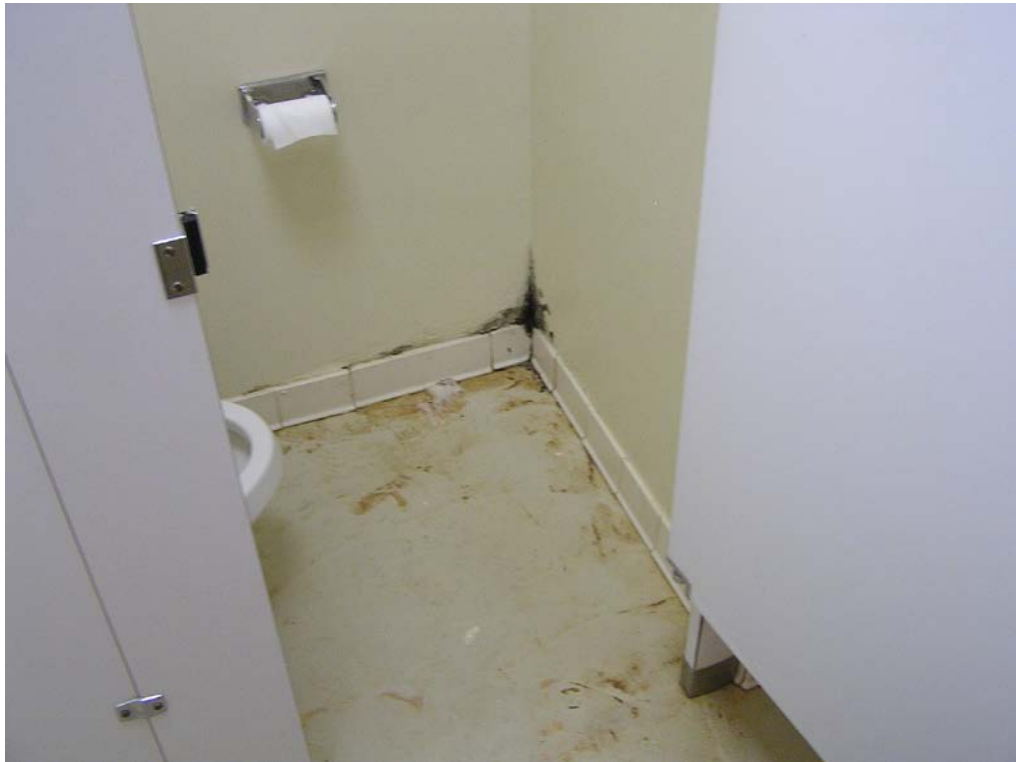
34. View showing deteriorated and mildew-stained gypsum board walls at the lower level men's restroom, indicating a possible foundation leak problem.

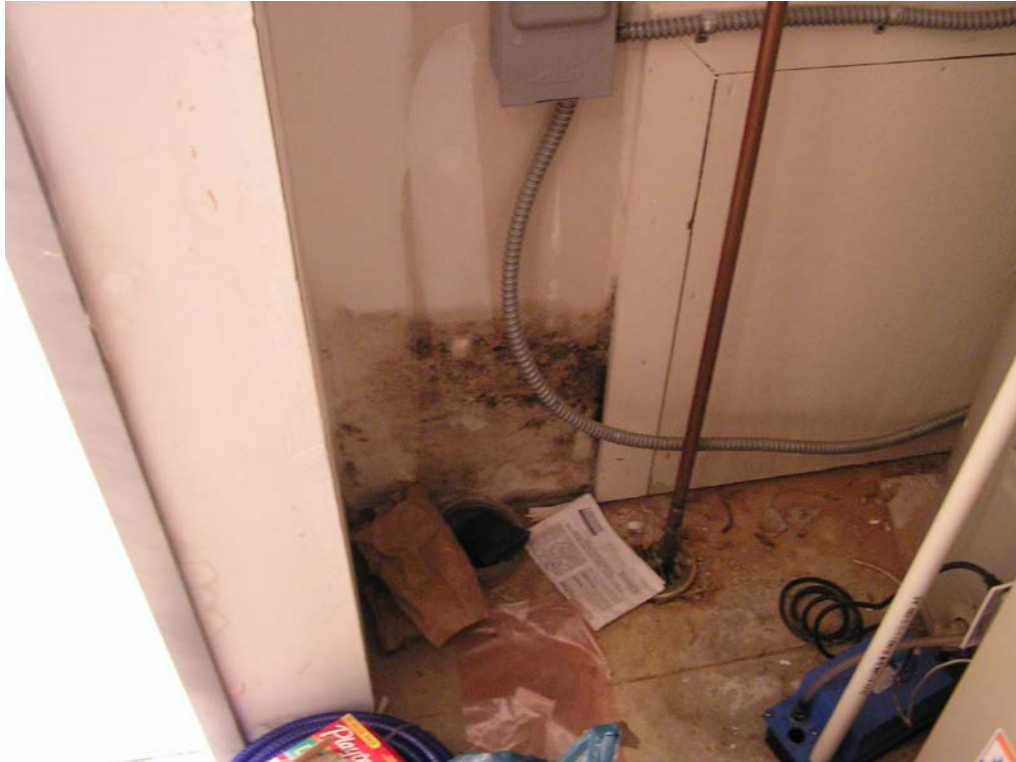
35. View showing deteriorated and mildew-stained gypsum board walls at the lower level mechanical room, indicating a possible plumbing leak problem.
