**CAPITAL RESERVE STUDY**  
FOR  
**REGENCY HILLS SUBDIVISION**

PREPARED FOR:

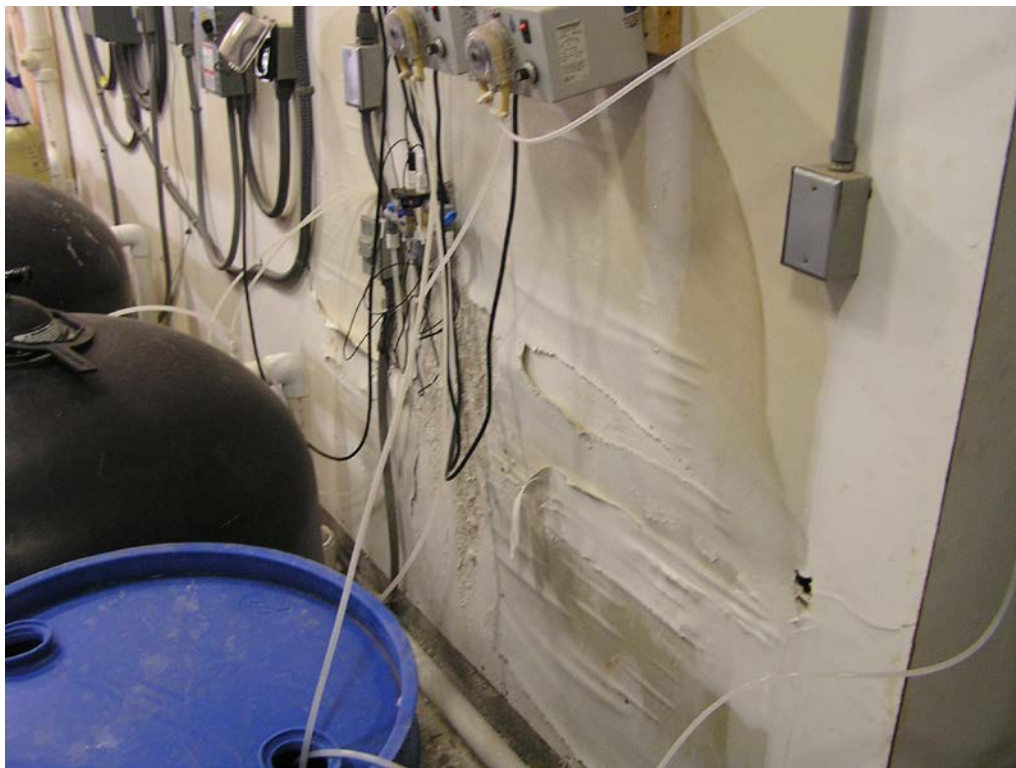
36. Deteriorated gypsum board walls in the pool equipment room.

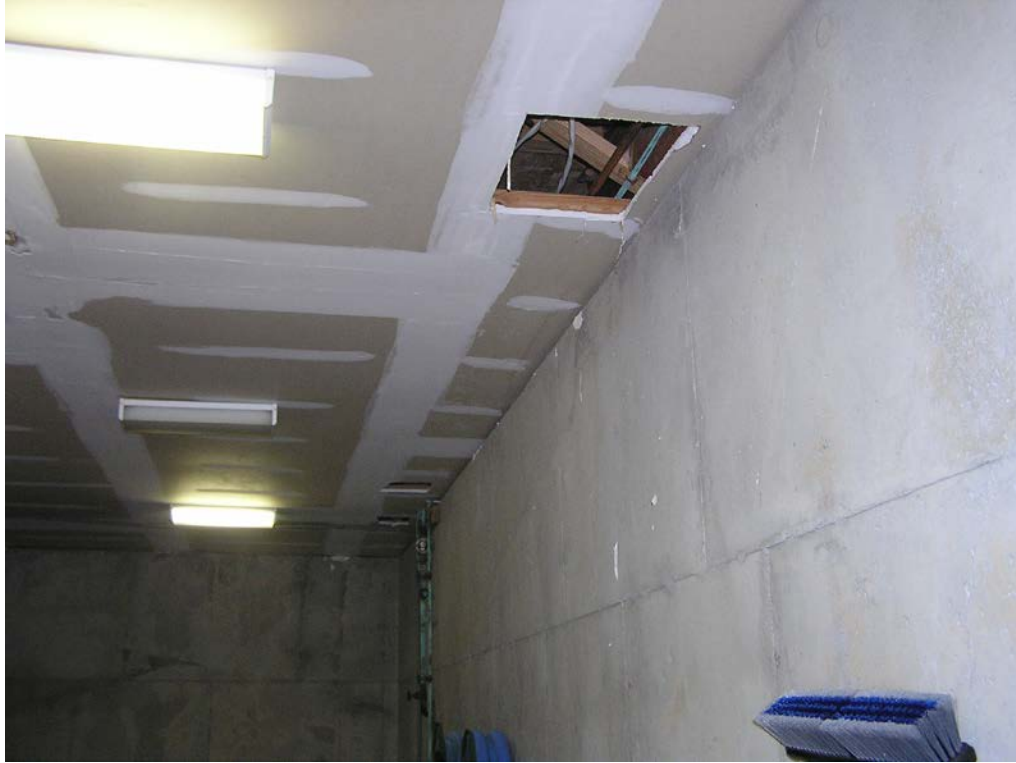
37. View of the pool equipment room ceiling showing access holes that have not been repaired.

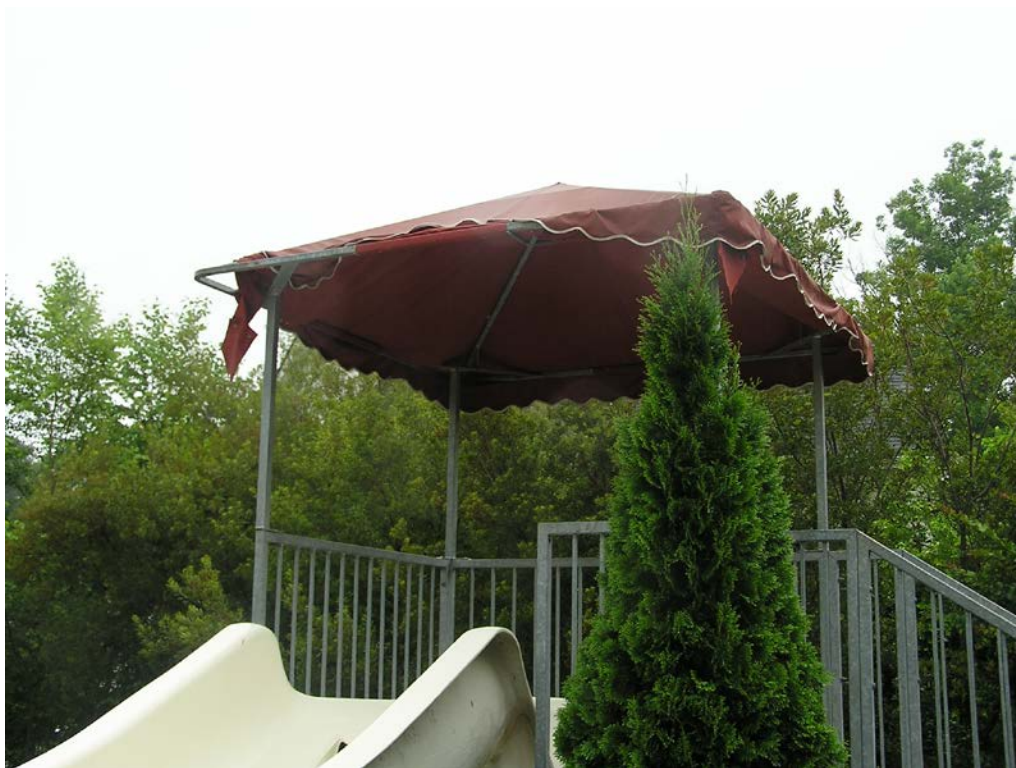
38. View of the deteriorated awning at the water slide.

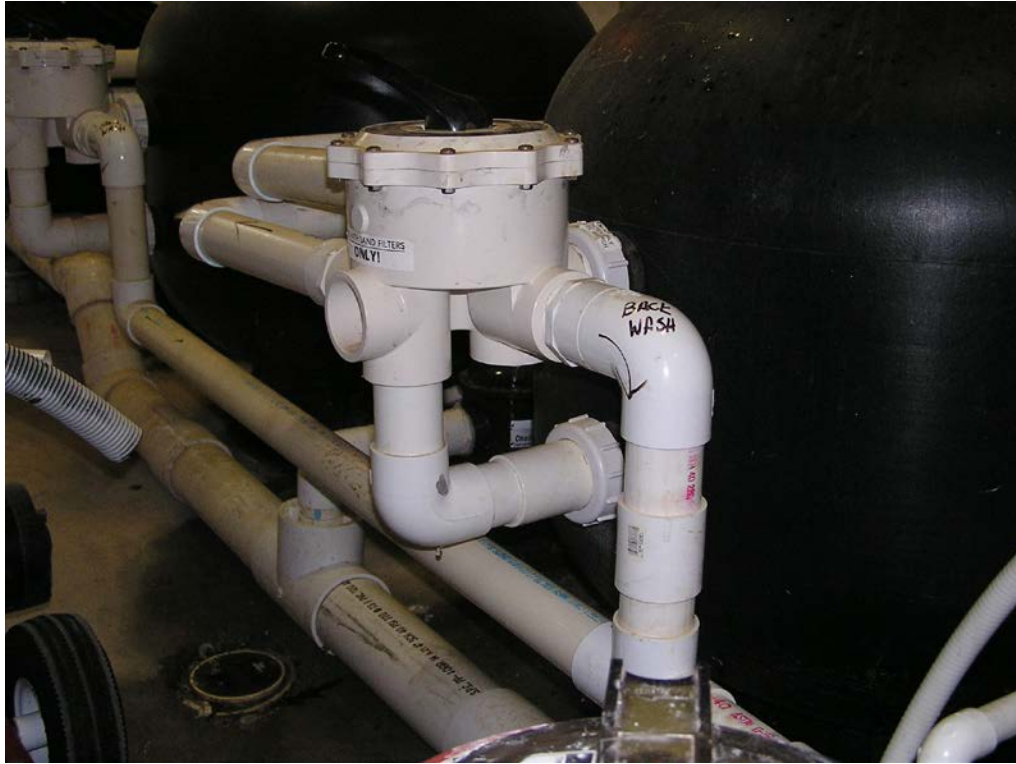
39. View showing the leaking valve at the filtration equipment for the main pool.

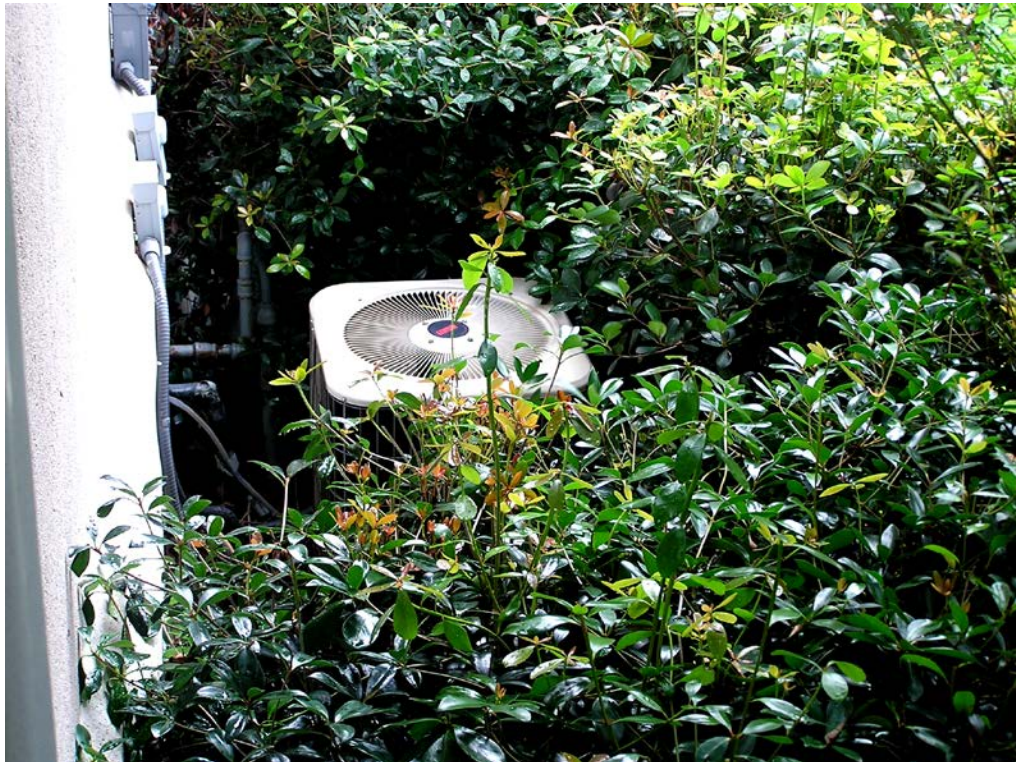
40. View showing the compressor units at the left side of the clubhouse that are almost enclosed by shrubbery.
